Study to estimate the service life of Phoenix EPDM roof sheeting

Expert report on exposed joint seams and repair capability of exposed Phoenix EPDM roof sheeting

Both carried out by SKZ-TeConA GmbH, Würzburg

Detailed versions: Final report No. 37236/99-V dated 14 August 2003 and
Expert report No. 41544/00 dated 5 December 2003

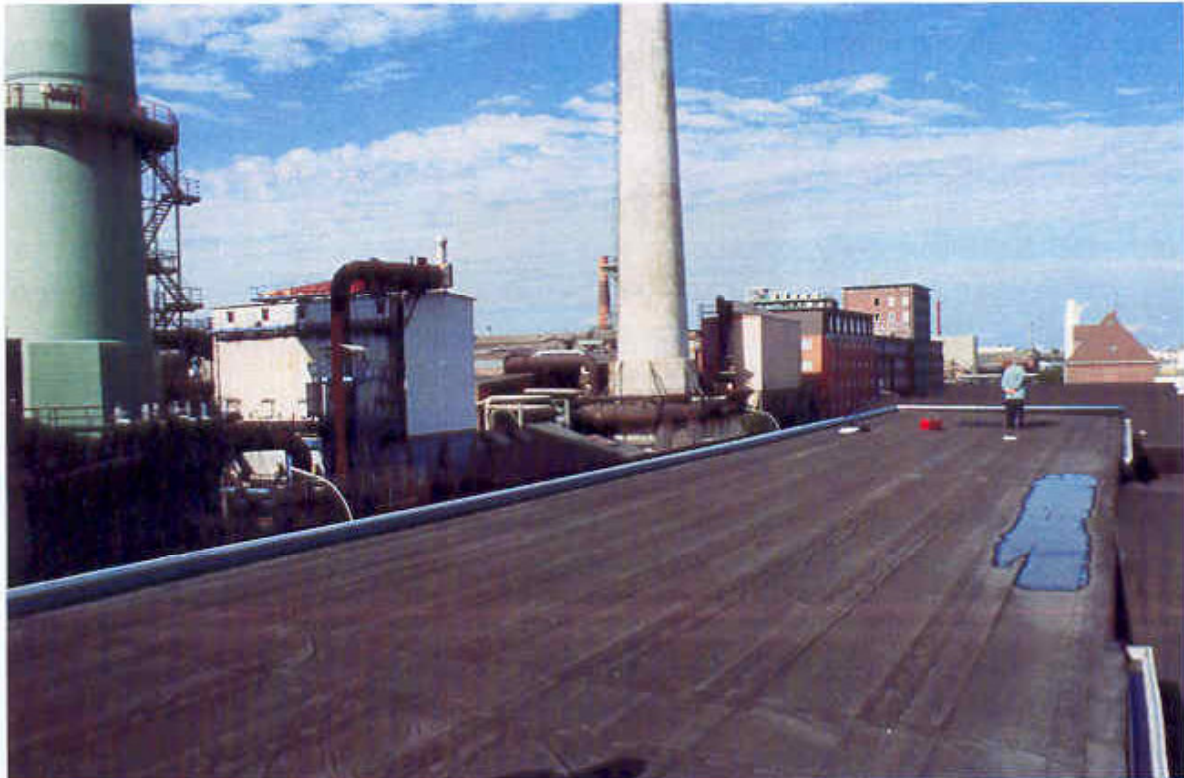
Fig. 1: Examination of the roof surface of BV „HH-Veddel, Industriegebäude“

The samples taken from the roofs did not reveal any visual signs of material damage. All lengths of roof sheetings still fulfilled their function as roof sheeting to the full.

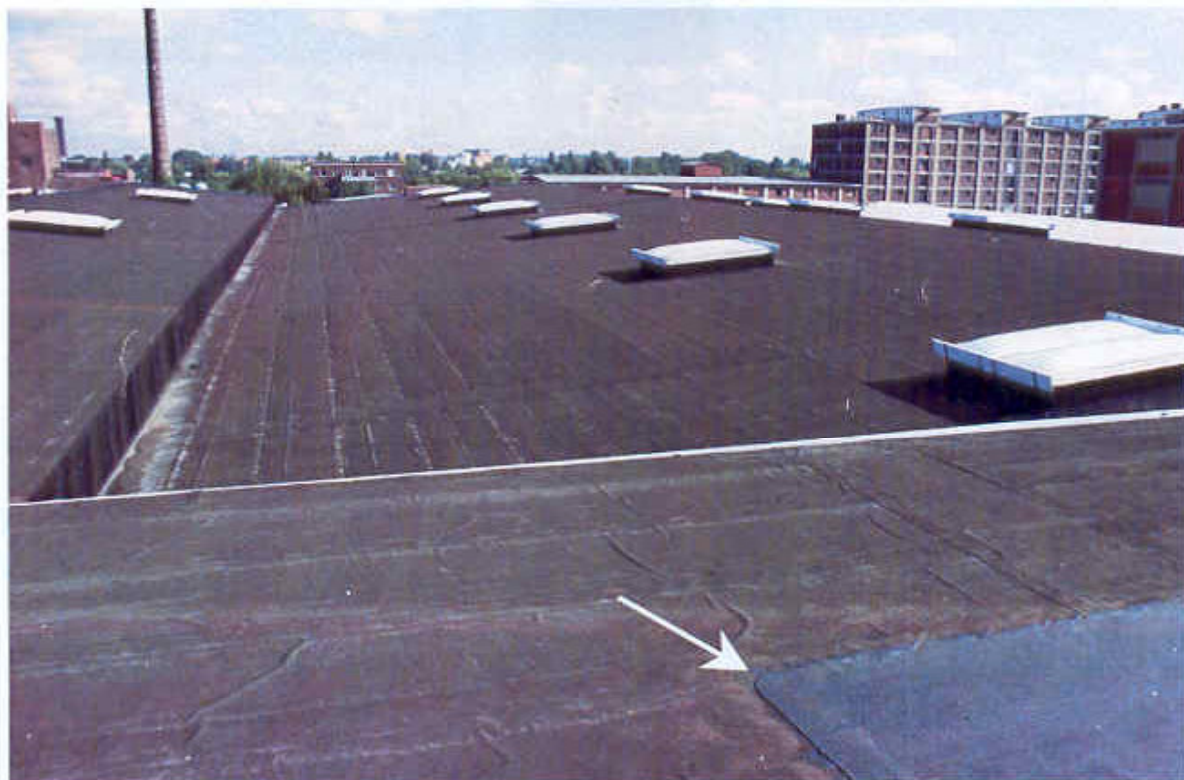
Fig. 2: Sample taken from the roof sheeting on the roof of BV „HH-Veddel, Industriegebäude“

To this end, 4 Phoenix EPDM roof sheetings which had been in use for up to 20 years were checked for their current condition and then subject to further artificial aging in the laboratory, in order to be able to estimate the remaining service life in each case. The comparison material for the exposed sheeting consisted of commercially available new products not exposed to any loads. In comparing the samples taken from the roofs with the new products, it was however important to consider that there could be a time difference of up to 20 years between the corresponding production of the sheeting, so that adjustments to the recipes must be expected.
